MERCED RIVER HABITAT TYPING,
UNDERWATER FISH OBSERVATIONS,
AND
HABITAT RESTORATION RECOMMENDATIONS

YOSEMITE NATIONAL PARK

*Tom T. Kisanuki
Thomas A. Shaw*

*May, 1992
Report AFF1-FRO-92-03
Region-1
Portland, Oregon*

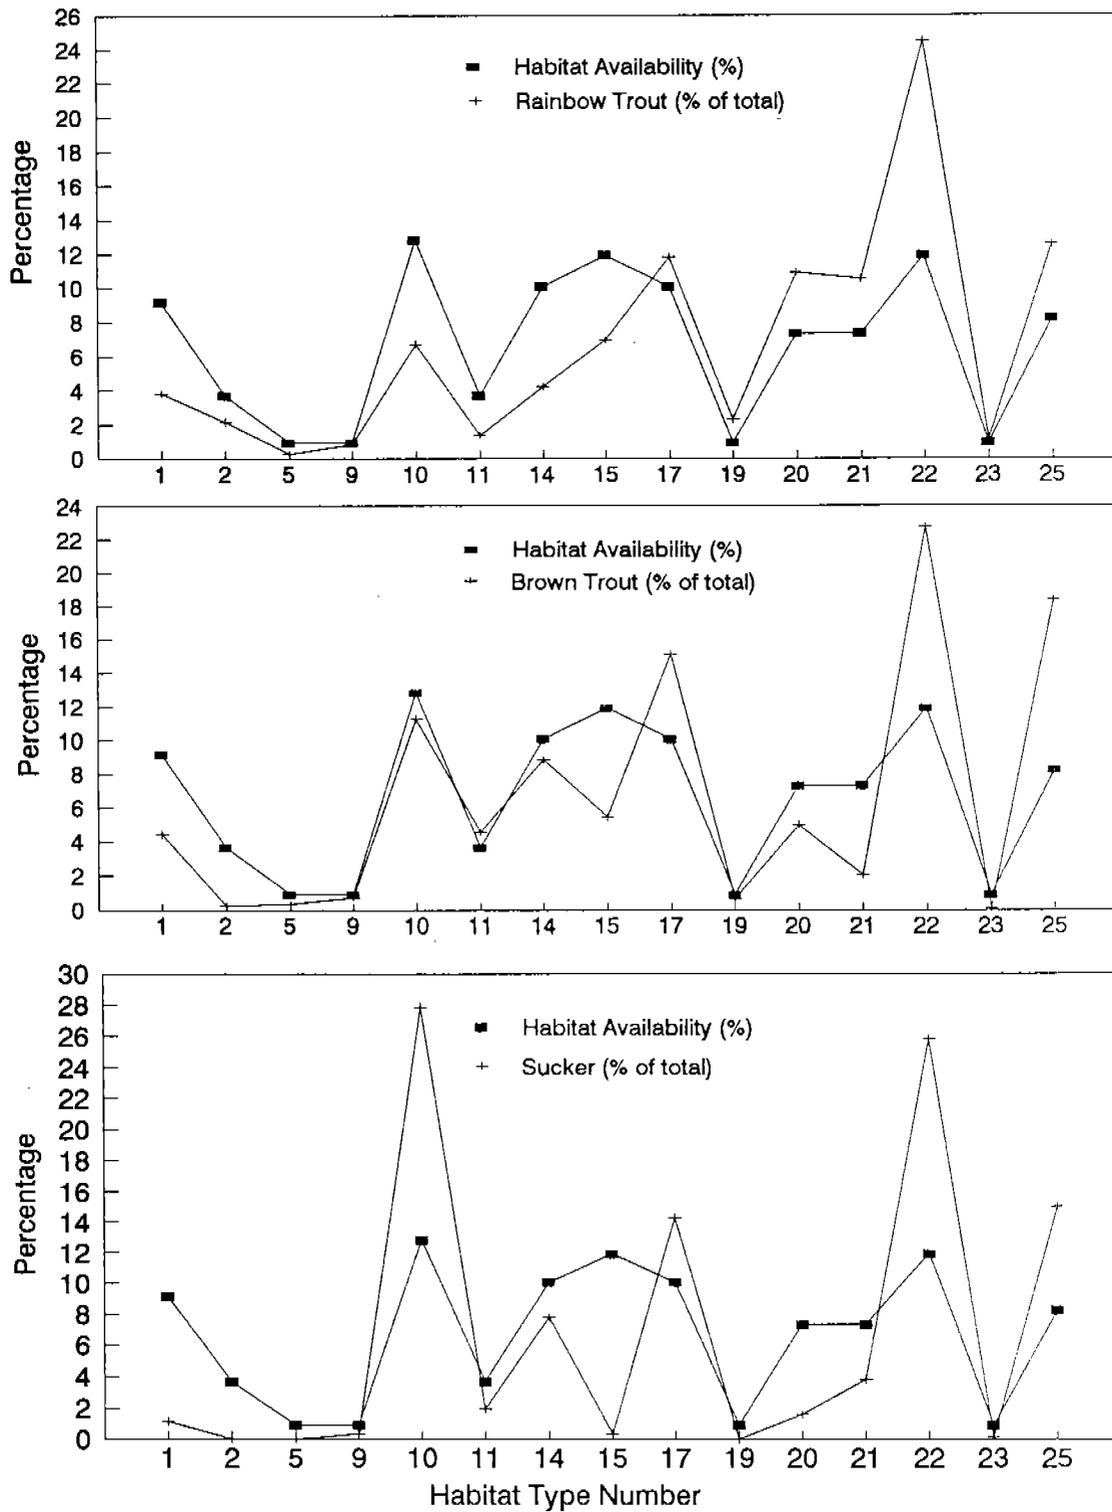
With a few specific exceptions, the three species of fish generally utilized the habitat types in proportion to the availability of these habitats (Figure 3). The underwater counts indicate that CRP habitats were heavily utilized by all fish (Table 6). For salmonids, the CRP and BSP habitats held the highest numbers of fish. Suckers displayed an affinity to LSP-log formed habitats, where 27.9% of all suckers were observed. The results also suggest that brown trout and sucker did not "favor" LSP-bo and POW habitats, whereas usage by rainbow was relatively higher. This may be related to the higher water velocity characteristics of these habitat types, which rainbow are known to inhabit. Despite this, all three species of fish displayed low usage in LGR, high gradient riffle (HGR), and POW habitats. This observed "under-utilization" or negative "selection" of these habitats may be related to two plausible factors. In riffles with larger (cobble) substrates, fish would be more difficult to observe, and thus would be under-represented in the observations. Secondly, fish may be seasonally emigrating from these habitats with decreasing stream discharge; particularly the adult life stages.

Figure 3. Habitat availability (percent occurrence) of main channel habitat type, and percent of fish observed per habitat type, for rainbow and brown trout, and Sacramento sucker.

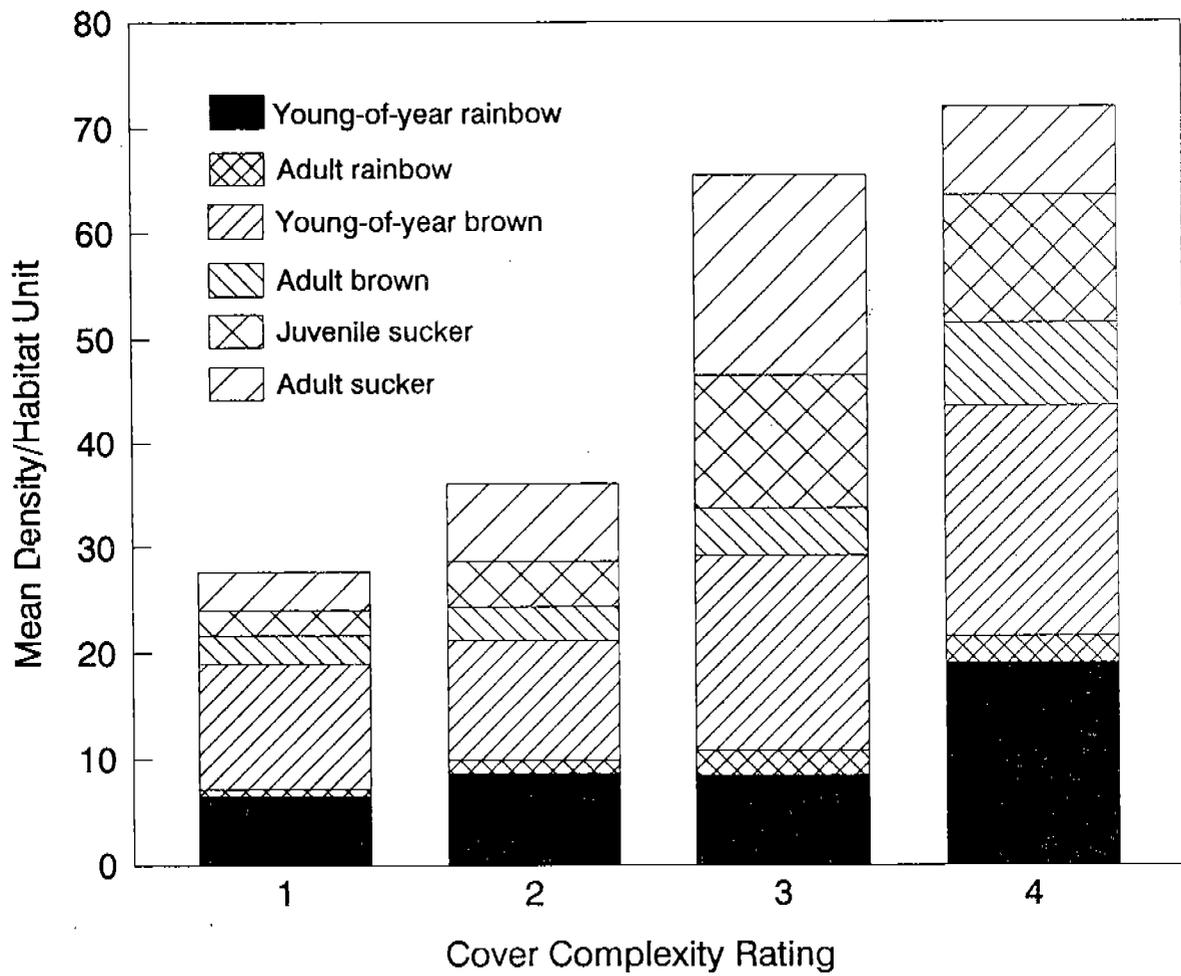
Figure 4. Relationship between cover complexity rating of Merced River main channel habitat types and mean number of fish per habitat type, for young-of-year or juvenile, and adult fish.

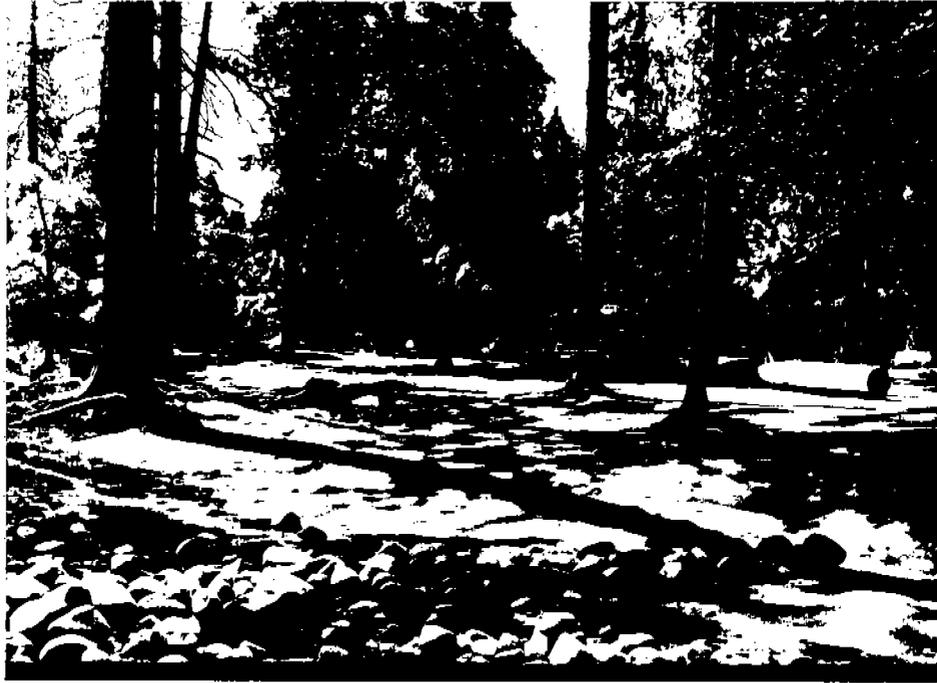
The exposed banks sustaining the greatest impacts were usually in association with public access points (parking areas, scenic vista points, foot and horse trails, etc) adjacent to trails, campground sites (Figure 5), and the housekeeping cabins (Figure 6). Although some of the exposed bank areas undergo cyclic periods of inundation and desiccation, and may otherwise have limited vegetation even under natural conditions, human impacts have prevented or severely limited the ability of grasses and other plants to become established in these streambank/riparian zones. Many of the sloughing banks were associated with access areas and horse trails. Erosion problems associated with horse trails were particularly noticeable upstream from the Pines campgrounds.

Figure 5. Left bank view of Pines Campground, downstream from Clark's Bridge. Soils are compacted, and the area is devoid of riparian vegetation.

Disturbed stream banks with compacted soils and trampled vegetation require exclusion from human disturbance, to re-establish vegetation. Resource area restrictions or closures are recommended. Severely affected streambank areas such as those adjacent to the Devil's Elbow Picnic Area may benefit from active intervention (where appropriate) such as manual tilling, recontouring

Limiting or closing access to disturbed sites is essential to prevent further degradation, and to promote rapid recovery of sites selected for revegetation efforts. If total access closures are not desirable to certain river areas, consider wooden walk-ways which would re-direct impacts away from disturbed areas. In areas with multiple access paths, reducing the number of undesirable access paths would be helpful. Identification of the main path through trail signs may help encourage proper usage. The Devil's Elbow parking area is another example of a heavily used area with compacted, crusty sandy soils and unlimited access to the streambank area (Figure 10).

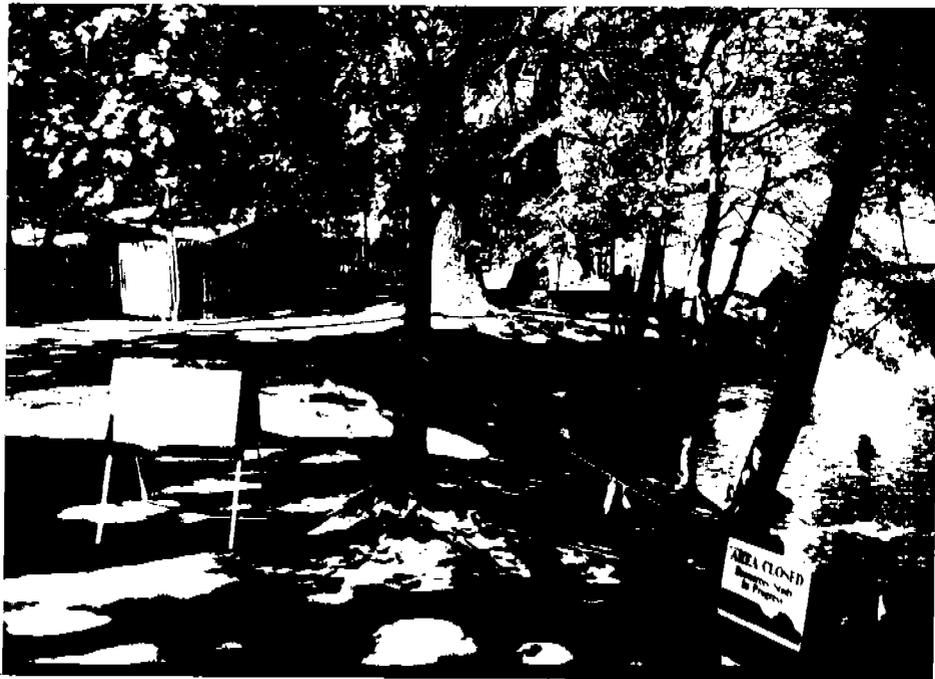
Figure 6. Housekeeping Cabins area. Compacted soils, riparian vegetation consists only of trees.

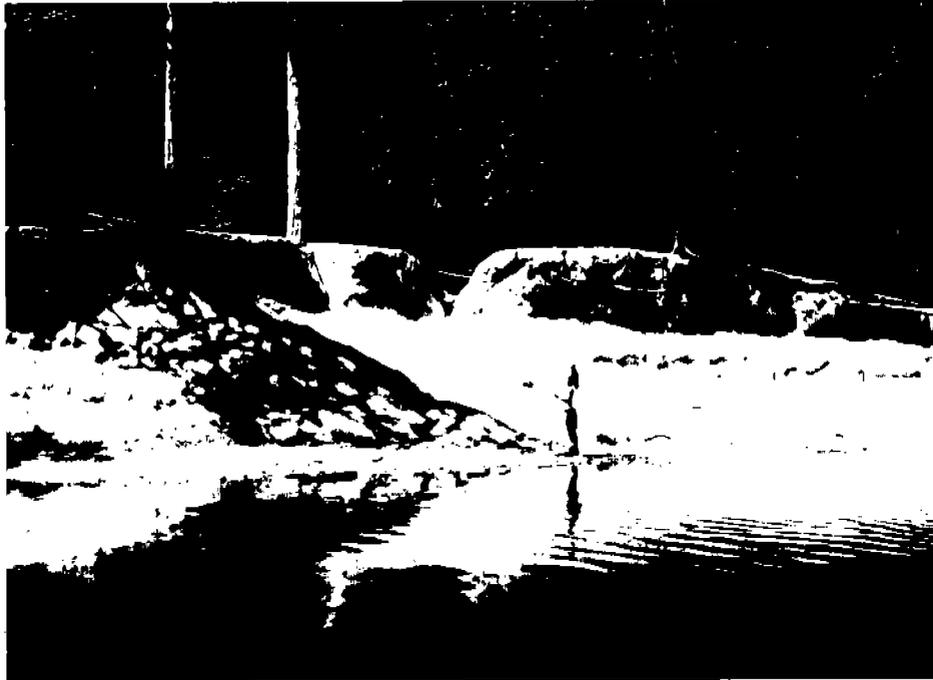
Headcutting and bank sloughing was observed in the meadows and other areas (Figures 7, 8). Some of the unstable areas were not in degradational zones, and overall, areas undergoing active erosion appeared to exceed areas of deposition. This was also noted by Madej et. al (1991). The factors responsible for many of the streambank problems were unclear to us. Due to the complicating human influences (bridges, rip-rapping, soil compaction, bare soils), the on-going fluvial processes were difficult to assess. These problems are best addressed by geo-morphic scientists; these topics were discussed in the report of Madej et al. (1991).

Figure 7. Streambank erosion, upstream from the Housekeeping area. Channel type C3.
